III-5-5. Geomorphology of Consolidated Shores

This section provides a review of the geomorphology of cohesive shores and the relationship between the land forms and the erosion processes discussed in the previous sections. The discussion is subdivided under two headings: “Controlling Factors” and “Profile Types.” This section focuses on the geomorphology of consolidated cohesive sediment shores. For more detail on erosion processes along rocky coasts, refer to Sunamura (1992).

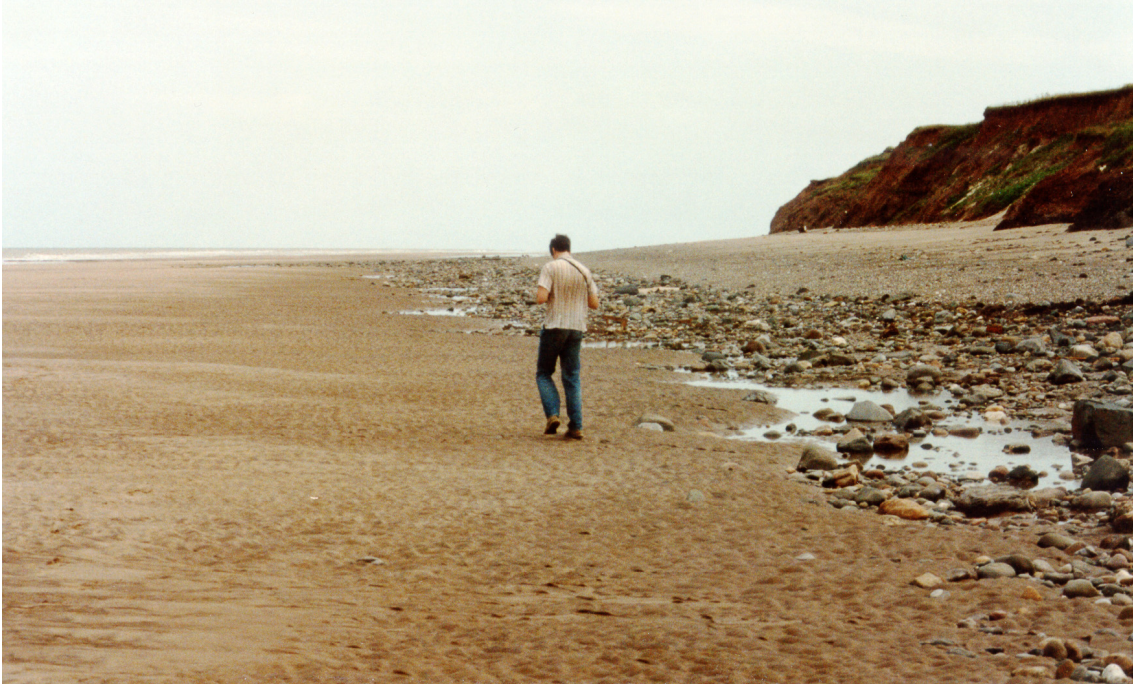
(b) Another important factor is the volatility or mobility of sand cover. If the overlying noncohesive bed forms are rapidly and frequently changing position, the underlying cohesive substratum will be exposed to erosive situations more frequently. Nairn and Parson (1995) have indicated that on the Great Lakes, the shift of bar position in response to changing lake levels has an important influence on the exposure of the underlying till (in the troughs between the bars) to erosion. On an eroding cohesive bluff shore along the North Sea coast of England, Pringle (1985) identified alongshore migrating areas of reduced beach cover and exposed glacial till called 'Ords.' These Ords have an important role in exposing the underlying glacial till to erosion. Figure III-5-13 shows an Ord on the Holderness coast at low tide with glacial till exposed (partly

covered with cobbles) between the upper coarse sand beach and a bar consisting of finer sand. The closeup photo of the Ord (Figure III-5-14) shows erosion of the exposed till around a 10-cm-high pedestal protected by a rock cap. Pringle (1985) found that the migration rate for these features was approximately 500 m/year, which is similar to the rate of migration for large sand waves or rhythmic features along Long Island, NY (Thevenot and Kraus 1995). An Ord could be defined as the area between two migrating sand waves. In summary, both cross-shore and alongshore variations in sand cover thickness resulting from migration of bars and sand waves or Ords, respectively, have an important influence on the rate of cohesive sediment erosion in the nearshore zone.

Figure III-5-13. Bluff erosion along the Holderness coast of the North Sea. The underlying cohesive profile is exposed at low tide in a trough (referred to as an “Ord”) between the upper beach and first bar

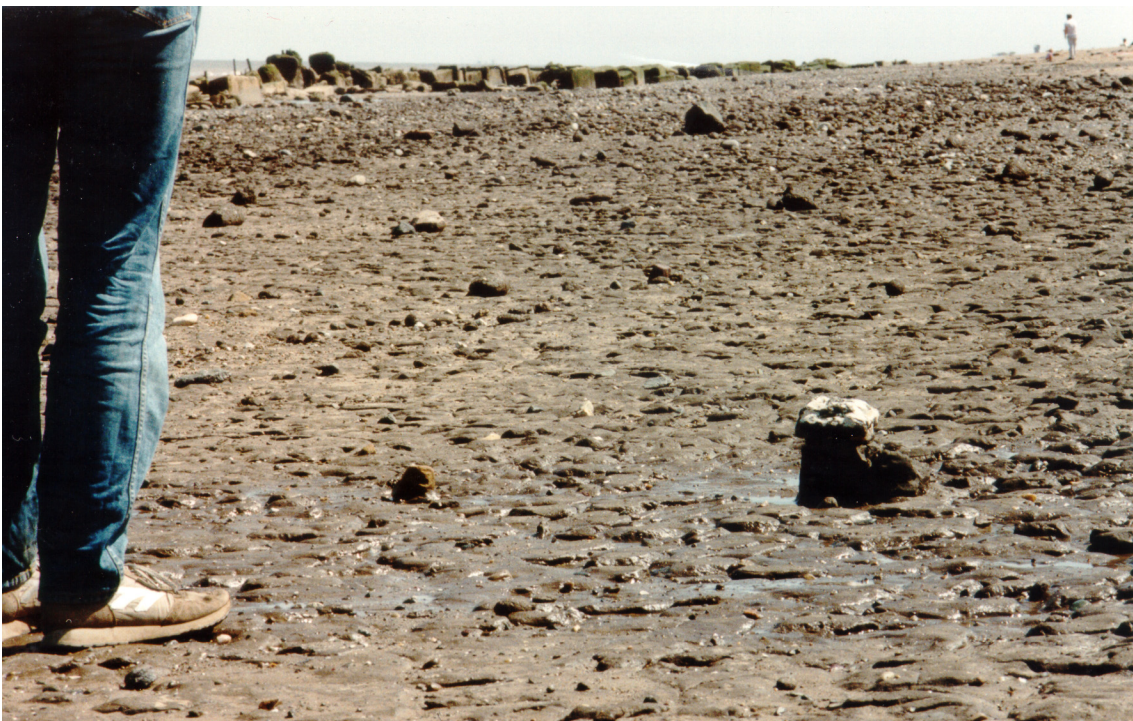
Figure III-5-14. Close-up of the exposed cohesive profile on the Holderness coast (Figure III-5-13). A rock-capped pedestal of cohesive sediment, about 10 cm in height, has developed through erosion of the adjacent seabed
